**IDAHO DEPARTMENT OF FISH AND GAME
2007 PANHANDLE REGION
MARBLE CREEK BULL TROUT PASSAGE ASSESSMENT**

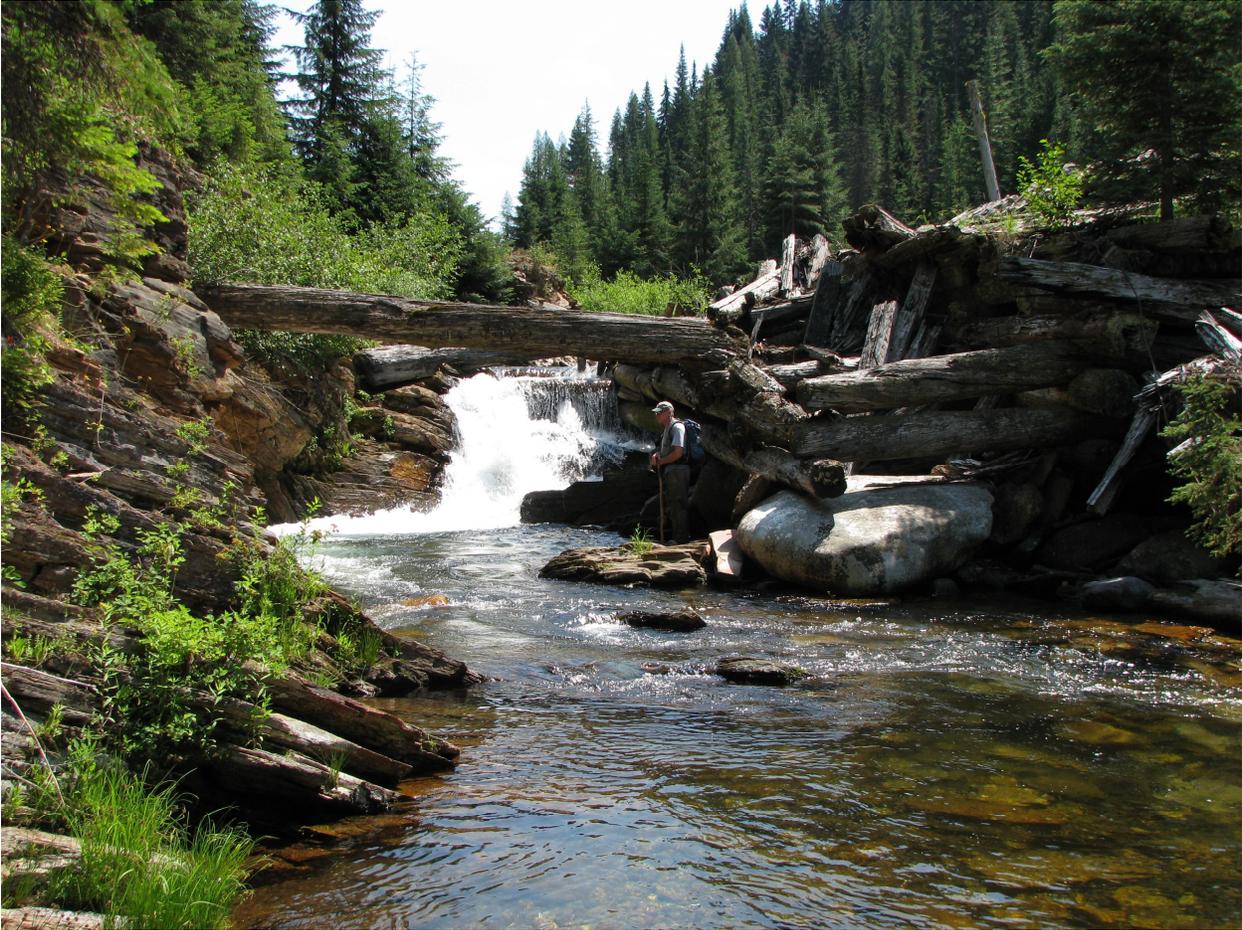
Appendix A.

The second dam (Splash Dam 2) we encountered was over 3m high. Most of the flow cascaded over this dam along its east side (Appendix A). Holding pools did not appear to occur anywhere in this cascade that would allow a bull trout to navigate its way over this drop. Significant flows also occurred through the log structures on the east side of the dam. Although we were doubtful that adult bull trout could navigate through the logs or ascend the cascading falls, it was impossible to determine this with certainty. We were able to crawl into parts of the splash dam, but darkness and splashing water prevented accurate evaluation. This splash dam was constructed by logs ranging from 0.2-1.0 m in diameter which were anchored to each other with spikes and a criss-crossing log pattern. Rocks were placed inside the log structure to help hold it in place. It appeared the reason most of the flow occurred along the east side of the dam was due to natural degradation from past floods and weathering. Those logs that remained in place were relatively large (> 0.7 m in diameter) and appeared to be largely intact. However, these logs would be susceptible to the continual pounding of water and debris carried in the flow which could significantly reduce the life of this structure.

The second dam we evaluated (Splash Dam 2) probably blocks upstream fish passage. Considerable flow occurs around and through the east side of the splash dam, but the 3 m drop is probably more that bull trout can handle. With fish passage above this second splash dam improbable, it blocks off 25 km of potential bull trout spawning and rearing habitat. Upstream from this site, all tributaries and the remaining reaches of Marble Creek are above 1,219 m in elevation. The largest tributary between Splash Dams 2 and 3 is Duplex Creek, which potentially provides bull trout spawning and rearing habitat. The stream gradient in Duplex Creek would probably limit bull trout use to the lower half, assuming no natural barriers occur. No known man made barriers occur in Duplex Creek to restrict bull trout movement. The logs that support Splash Dam 2 appeared stable, although where the majority of the flow occurs they must endure a continual pounding of water and debris. This process could significantly reduce the life of this structure and makes its susceptible to failure from future flood events.

Looking upstream at Splash Dam 2 in Marble Creek, Idaho, on July 27 2007..

1. Discuss with the Forest Service techniques that could be used to provide fish passage around splash dams 2 and 3 while maintaining their historical significance.
2. Assess whether the splash dams in Homestead Creek and Hobo Creek prevent bull trout from reaching quality spawning and rearing habitat.
3. Periodically assess the condition of the splash dams to determine if fish passage has changed.
4. Periodically assess the fishery in those tributaries of Marble Creek where we believe bull trout can successfully re-colonize. If these streams are not re-colonized by bull trout in 10 years, it may be wise to discuss the possibility of re-introducing bull trout into areas where we believe high quality habitat occurs.

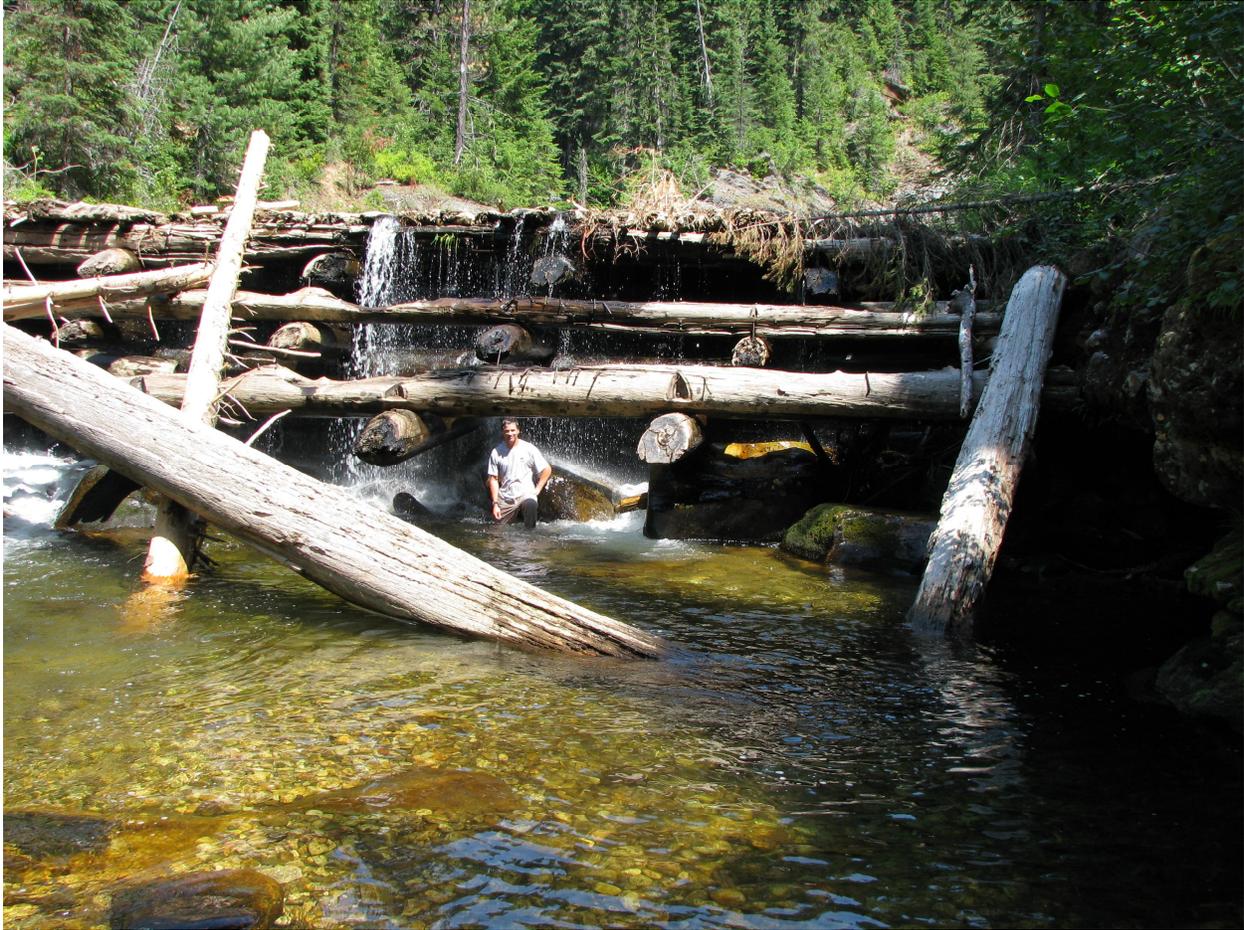
Appendix B.

The third splash dam (Splash Dam 3) we encountered we believe was a total block to upstream fish passage (Appendix B). The majority of flows either occurred over a 3m vertical drop or passed through narrow slots in the logs. We believe the vertical fall is more than bull trout can jump and we did not observe any possible route through the dam. The dam structure was 3m high and spanned the wetted width of Marble Creek. Logs used to construct the splash dam ranged from 0.2-1.0 m in diameter. This dam was constructed similar to Splash Dam 2,

but it appeared to be very stable and entirely intact. After nearly 100 years of use, sediment had filled the channel to the top of the dam. This would allow large debris or substrate to pass over the dam during higher flows without causing much damage to the structure.

Splash Dam 3 occurs about 2.3 km upstream of Duplex Creek. This splash dam completely blocks all upstream fish passage. We crawled around the splash dam evaluating its structure and it appeared in very good shape and entirely intact. Floods will likely have minimal impacts because sediment build up on the upstream side of the dam allows substrate and other debris to flow over the splash dam with minimal contact. Based on its stability and resistance to flood impacts, Splash Dam 3 could potentially pose as a fish barrier for the next 100 years. If fish passage is desired in the near future above this splash dam, alternative passage routes would have to be developed. Upstream of Splash Dam 3 is Freezeout Creek, Delaney Creek and the upper reaches of Marble Creek. These streams are above 1,219 m in elevation and contain what we believe to be the best bull trout spawning and rearing habitat in the Marble Creek watershed.

Looking upstream at Splash Dam 3 in Marble Creek, Idaho, on July 27 2007.

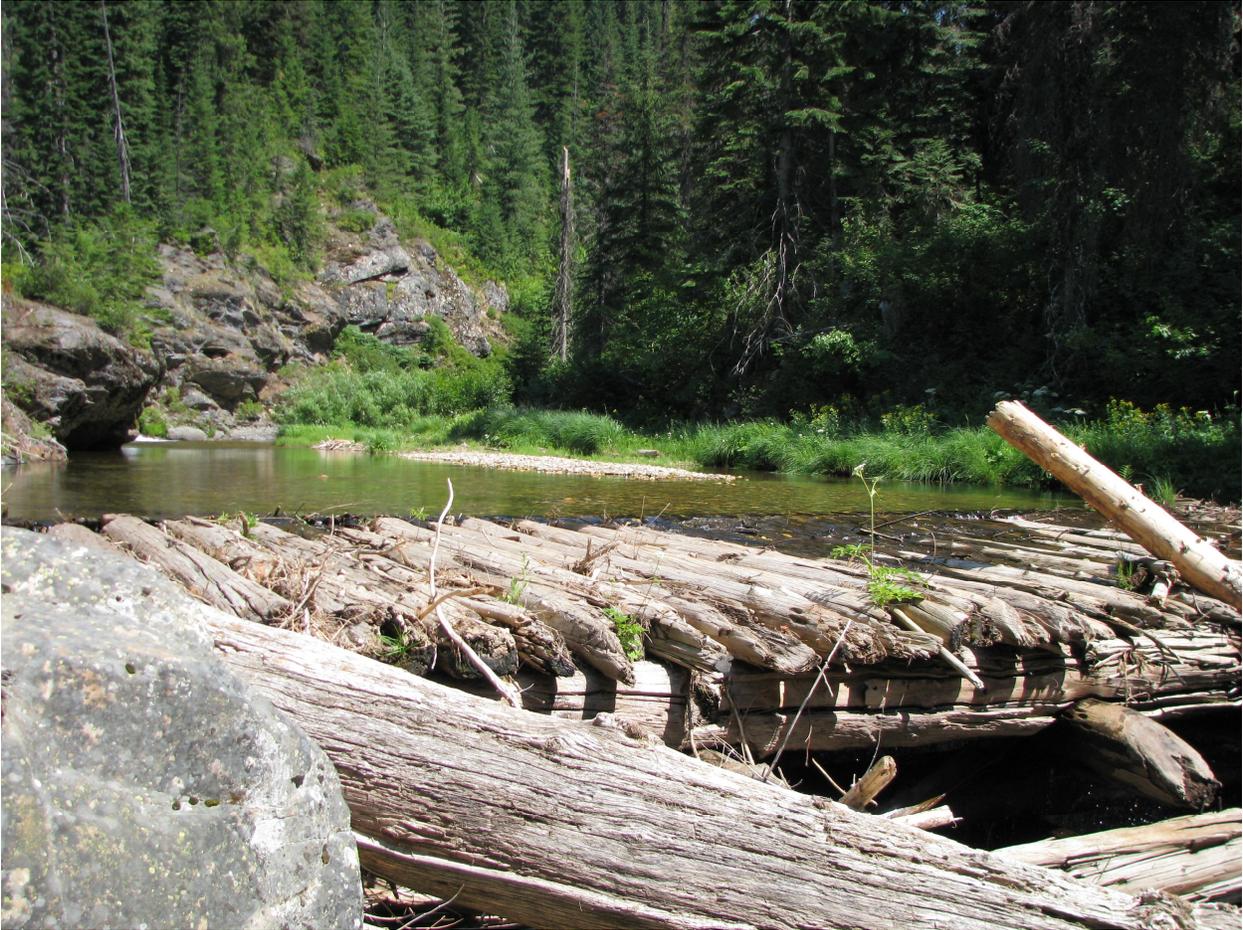
Appendix B (continued).

A top view of Splash Dam 3, looking upstream in Marble Creek, Idaho, on July 27 2007.

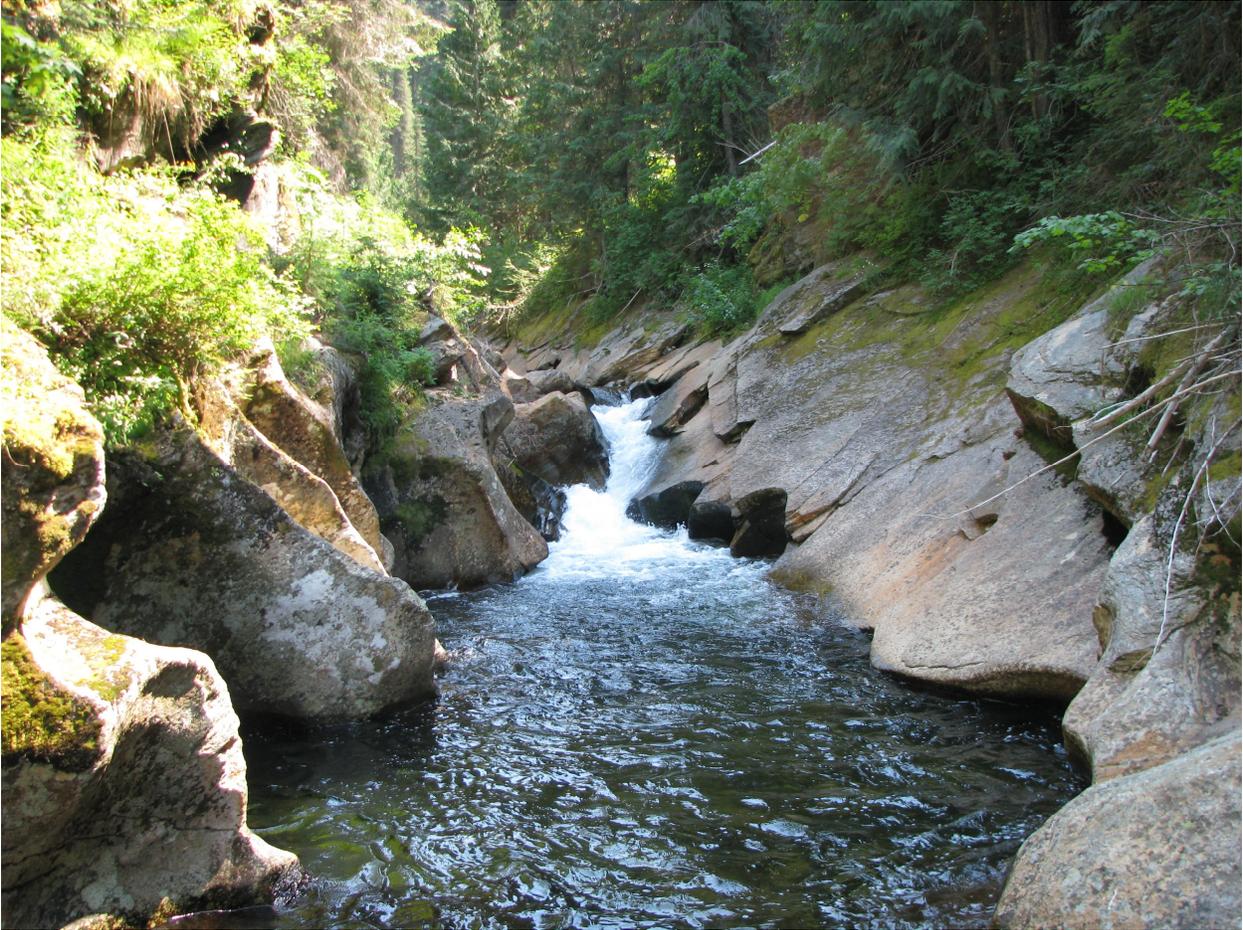
Appendix C.

We encountered two natural falls between Splash Dams 3 and 4 that could potentially pose a fish barriers to adult bull trout. The first fall was cascading with a total elevation drop of approximately 3 m (Appendix C). The second fall had a 2.5 m vertical drop. Both of these falls occurred in a narrow (1.5 m) bed rock canyon. During higher flows we believe the drops to these falls would be significantly reduced and several possible routes would be available. During these conditions, we believe adult bull trout (> 500 mm) would be able to pass these falls.

View of Falls 1 in Marble Creek, Idaho on July 23, 2007.
